# Manhole Inspection Summary

Manhole # S23C1\_001MH

**Location** Address: **2404 Huron -Ridgey St**

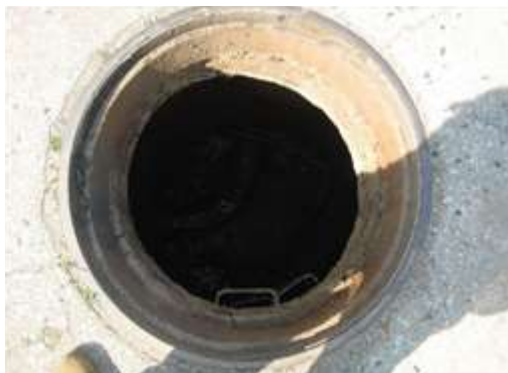
miscellaneous

**Frame** Offset: **2** (in.) Condition: ☐ Sound ☐ Cracked ☒ **Leaks**

frame leaks

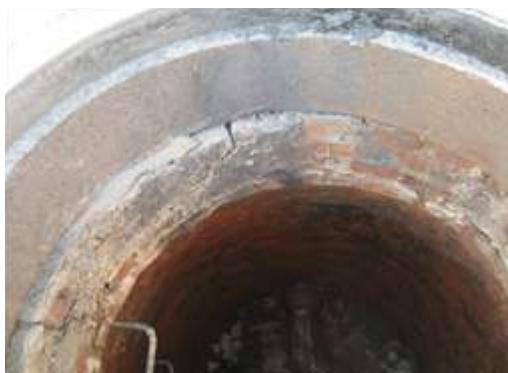
Defect 3

Condition: ☐ Sound ☒ **Cracked** ☐ Root Intrusion ☐ Loose Brick ☐ Deteriorated

Infiltration: ☐ None ☒ **Joint** ☐ Cracks ☒ **Mortar** ☐ Roots ☐ Wall

additional view of leaking frame and cracked bricks chimney with infiltration

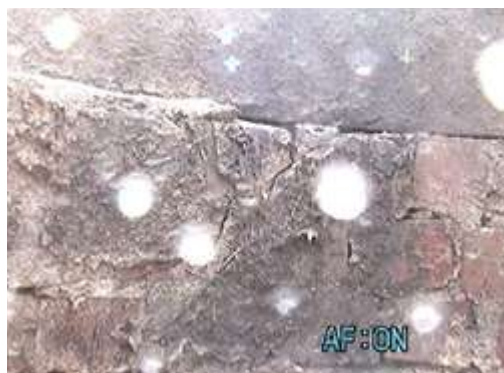
Defect 2

chimney cracked, infiltration lid-frame joint

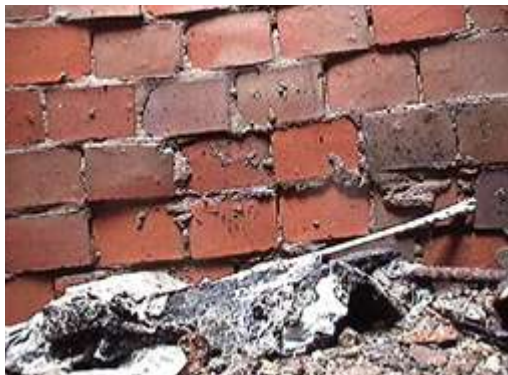
Defect 1

Condition: ☐ Sound ☐ Cracked ☐ Root Intrusion ☐ Deteriorated ☐ Leaks ☒ **Debris**

debris on bench

Comments **Sticks need to be removed.**

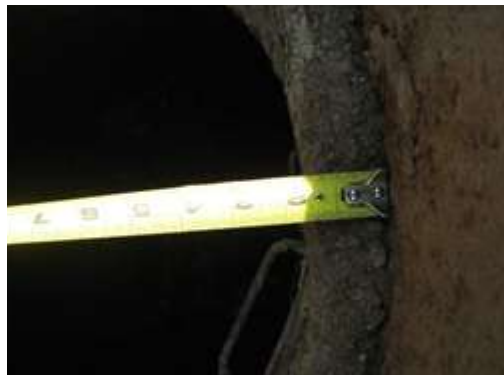
Defect 4

2" offset
